DISASTER MITIGATION THROUGH CONSERVATION OF HERITAGE BUILDINGS IN PESHAWAR CITY

HAFIZ ASFANDYAR AHMED¹, KHAN SHAHZADA², BASHIR ALAM², MOHAMMAD JAVED², SYED MOHAMMAD ALI², SYED MUSTAFA ALI SHAH¹

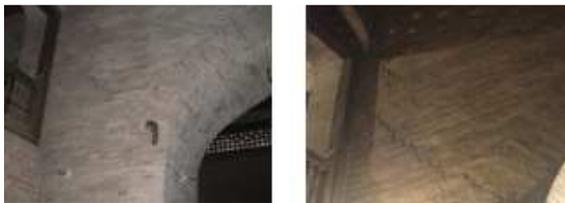
These Cracks start from the corner of wall and continues through the arches diagonally. These cracks were due to the shear failure of the arches. As shown in figure 1.

Figure 1 Shear Cracks in Arches

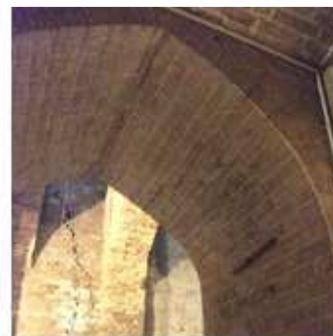
These cracks were observed mainly in the arches of basement and Level I. These cracks were perpendicular to the arch axis. These were straight, erected and passed throughout the arch width as shown in Figure 2. These cracks were formed due to the differential settlement of the foundation beneath.

Figure 2 Cracks due to Differential Settlement of Arches

The arches were cracked mainly due to differential settlement of the footing beneath them. The cracks were filled out by the mortar made by mixing lime and Surkhi and/or jute where necessary. The grout injection method was used for filling the cracks because of its good efficiency in filling up the joints. (Figure 8)

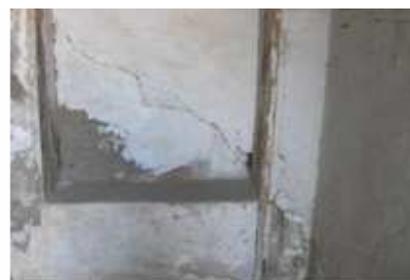
These cracks were observed in some walls but they were not so deep and wide. These cracks were diagonal and were observed in some partition walls of the building. (Figure 3)

Figure 3 Shear Cracks in Walls

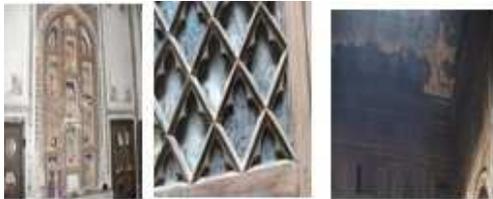
deterioration. The glass work made on slabs was also broken at some corners of the slabs. The walls were totally out of order. The glass work in windows was also broken at many places. Doors due to very rough use gave a bad effect. Approximately all the wood work lost its shine and gloss. However, it remained safe from termite attack in many places except very few. So the beautiful and historical decoration work which is seen very less now a days was losing its original meaning and getting deteriorated day by day. (Figure 7)

Figure 7 Deterioration of Decoration Work

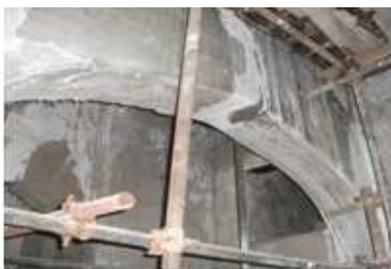
Figure 8. Rehabilitation of Arches

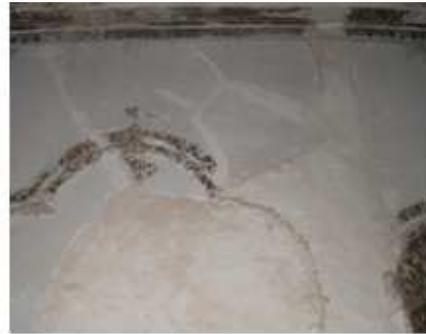
Figure 9. Rehabilitation Of Walls

The rehabilitation of walls was also done in a manner that all the cracks were first filled by grout made of Lime and surkhi. The injection method of grout was used as the cracks were very narrow. So to fill all the cracks properly, the grout injection method was suited. After that the plaster was made by using gifto gym fine plaster. (Figure 9)

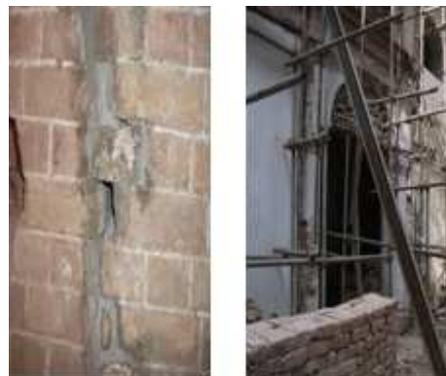
The North Eastern part of the house was getting separated from the main building and the orthogonal walls of both the blocks got a part of approximately 5-7 inches. That might be due to the excessive settlement of foundation at the North Eastern side of the house. The part was totally isolated from the main building as shown in figure 6.

Figure 10 Rehabilitation of North Eastern Part of House

i. First of all the portion was supported by bracing it laterally with the steel beams in arrangement shown in figure below. Because the portion was getting tilted continuously with the passage of time. So the purpose was to stop that separation.

ii. The upper part of this portion was grabbed by the steel cables, wound on all sides of the portion and supported with the main structure.

iii. The separation which was up to 5-6 inches between both the parts was filled by the mortar made of lime, jute, cement and sand. Attention was given to make the grout stronger.

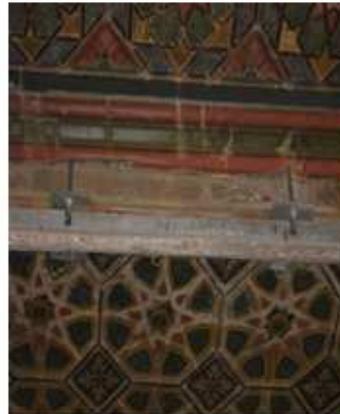
- i) Too much mud was laid on the slab. Approximately 24-28 inches of mud layer was laid in different times. Due to this, dead load on slab increased very much, thus causing the serviceability problems i.e. Deflection, Cracking etc.
- ii) Different users tried to use the roof slab for different purposes according to their requirements. Thus they converted the open area into a kitchen or Toilet, and making its drainage accordingly. As the original drainage system was got hidden under that mud layers it caused the leakage of water into the slab and wood works, which made lot of damage to the nominal strength of the affected materials.

Figure 11 Roof Slab

The extra layer of mud which was laid after many years was first removed so that the extra dead load can be removed from the slab. The natural drainage of the slab was restored because it was causing damage to the structure. Polyethylene sheet was laid to resist water penetration, then jumbolon was placed for the proper heat insulation over which 2 to 3 inch layer of mud was placed and the original bricks were placed

over it in the same old fashion and joined with the material similar to that originally used before. The roof slab of North Eastern part was also rehabilitated by first removing of the extra mud layers to reduce the dead load. Then the deflected slab was lifted by means of external prestressing of the slab as shown in figure 11.

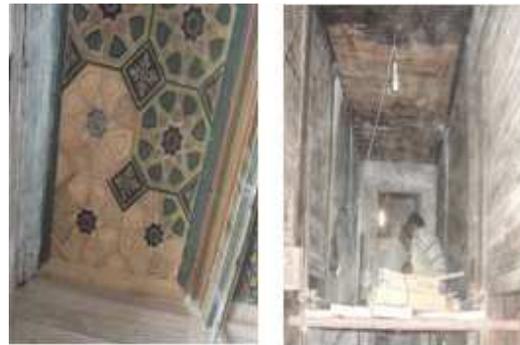
Figure 12 Repair of Decoration Work

- i. Repair of ceiling Decoration Work.
- ii. Repair of Windows & Doors Decoration Work.
- iii. Repair of Walls Decoration. (Figure 12)

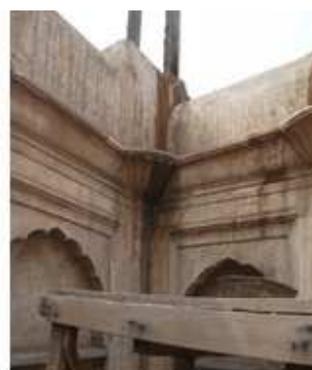
The parapet wall was also damaged and large numbers of cracks were found to appear in it. It has started losing its stability.

Figure 13 Rehabilitation of Parapet Wall

Parapet wall was also rehabilitated in the same manner by filling all the cracks in it and providing it the extra stability where required. (Figure 13)
