## THE EFFECT OF FRAME LEAKAGE ON PERFORMANCE OF INTERCONNECTING TRANSFORMER, MONITORING BY DGA CASE STUDY

ER. D. P. ASHTIKAR, PROF. P. S. SWAMI

1. Dy. Ex. Engineer, 400 kV Receiving Station, MSETCL, Waluj Aurangabad, Maharashtra,
2. Dept. of Electrical Engineering, Govt. College of Engineering, Aurangabad, Maharashtra.

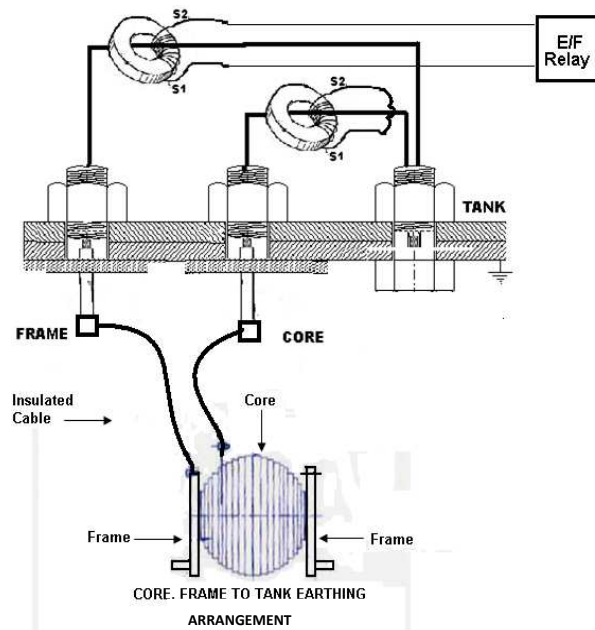
Figure 1: Schematic Diagram of

#### Frame – Core- Tank Interconnections

After installation and commissioning of the proposed frame leakage protection, it is expected that when insulation between frame and tank starts weakening and conducting loops are formed, frame leakage protections should raise alarm to indicate the situation for necessary further action to be initiated to prevent such type of failure in future, refer figure 1.

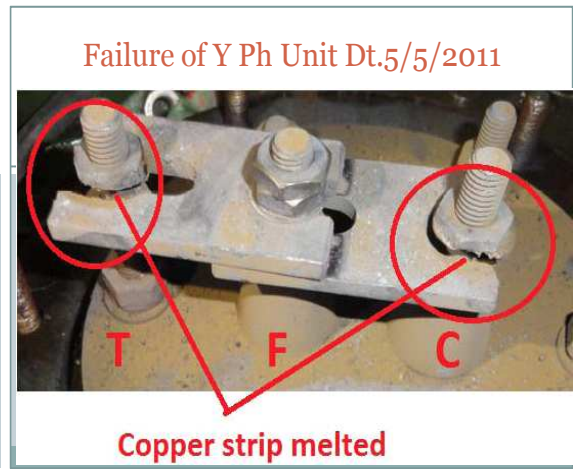
However for R and Y-Ph Units for the case under consideration, frame to tank continuity resulted in forming a conducting loop and thereby gave rise to circulating current which ultimately led to localized overheating and development of incipient fault.

Figure 2: Photograph of tank, core and frame strip connections

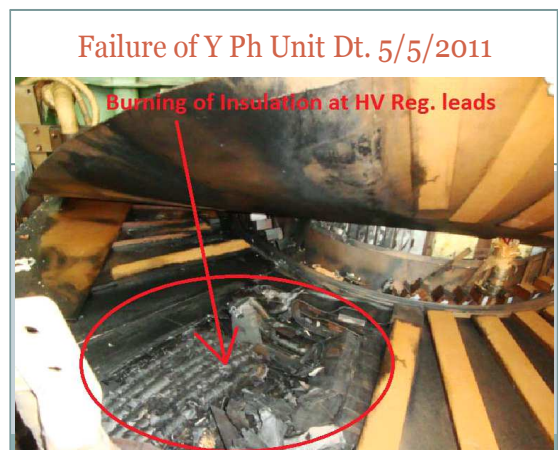
As the ICT was commissioned with the above mentioned 'frame to tank continuity' – which is undesirable –it led to failure of Y-Ph unit mainly due to frame leakage current.

Figure 3: Fault inside the Transformer

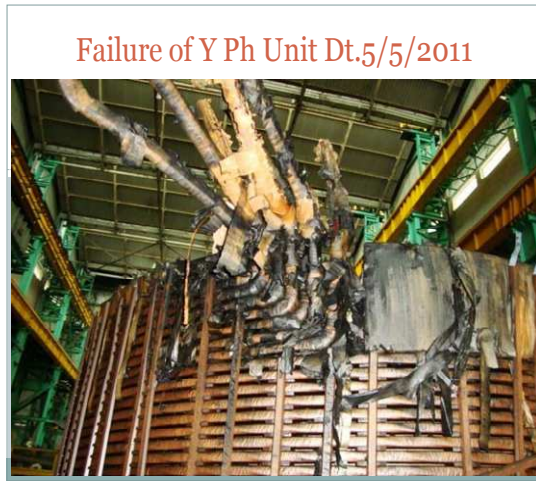
After commissioning of ICT, it was decided to monitor health of ICT by a traditional effective tool i.e. Dissolved Gas Analysis [2]. Manufacturer of ICT has its own developed laboratory for DGA and MSETCL outsourced services to local agency for DGA by using Solid Gas Chromatography technique. Results of DGA indicated that Fault Gases such as Acetylene, Ethane, Ethylene, and Methane were absent i.e. BDL (below detection level); however Y-Ph unit failed on Dt.05/05/2011. Quantum of Acetylene measured before failure was BDL (below detection level) ppm and after failure, it was 1082 ppm. After failure, tank to core and frame to core copper strips (12.5 mm thick) were found burnt. Failure photo graphs are shown in figure numbers 2, 3 and 4.

Figure 4: The failed winding top layer

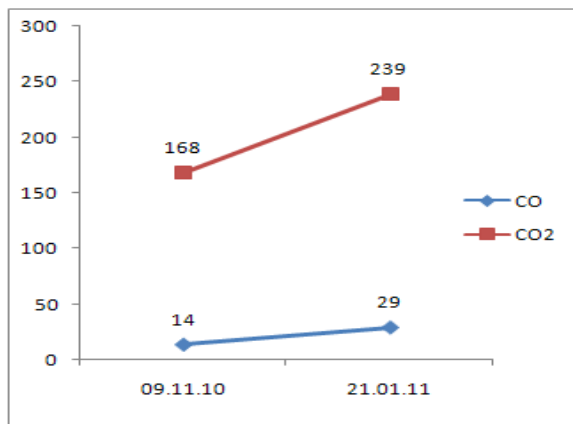
Figure 7: Results of failed unit

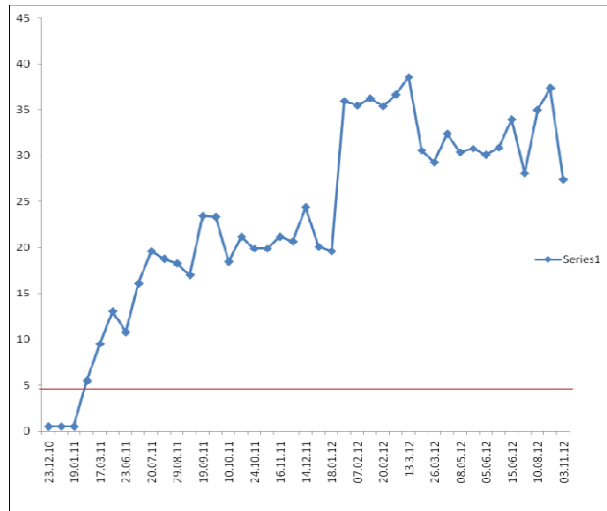
Figure 10: Acetylene growth sick unit

may also be formed if the fault involves cellulose decomposition [6]. The oil may be carbonized. Key gas for arcing is Acetylene ( $C_2H_2$ ). In present case of R phase unit, Hydrogen rose from < 5 ppm to 78 ppm and Ethylene  $C_2H_4$  rose from < 1 ppm to 158 ppm and Acetylene  $C_2H_2$  rose from 0.5 ppm to 38.6 ppm, this implies arcing in Transformer tank [7]. Manufacturer was initially reluctant to agree that R- Ph unit is sick, but then with above DGA results, he agreed for removing R- Ph unit for internal inspection and rectification of trouble at the risk and cost of manufacturer.
