# INTERNATIONAL JOURNAL OF PURE AND APPLIED RESEARCH IN ENGINEERING AND TECHNOLOGY

## EXPERIMENTAL INVESTIGATION OF REINFORCEMENT COUPLERS AS REPLACEMENT OF BENT BAR

ROHITKUMAR A. PANDEY<sup>1</sup>, CHIRAG N. PATEL<sup>2</sup>

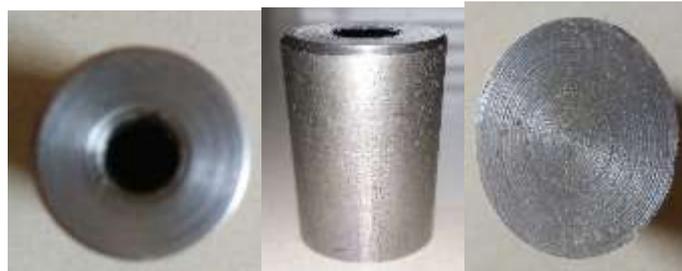
Figure 2 Reinforcement coupler

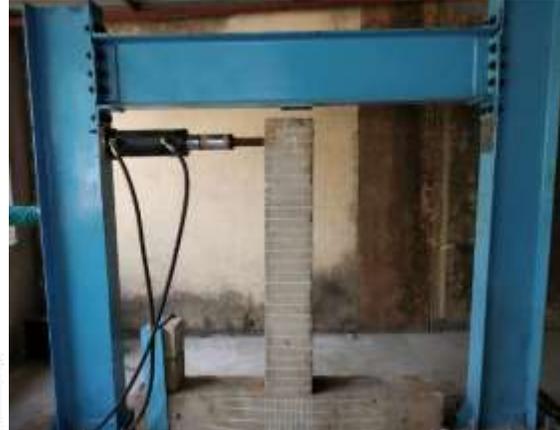
Figure 6: Filed arrangement of test setup

The half-scale exterior beam-column joint specimen testing was carried out at, Government Engineering College, Modasa, Gujrat, INDIA. The joint assemblage was subjected to monolithic loading using of 25 ton (250 kN) capacity hydraulic jacks. The specimen was oriented as described below.

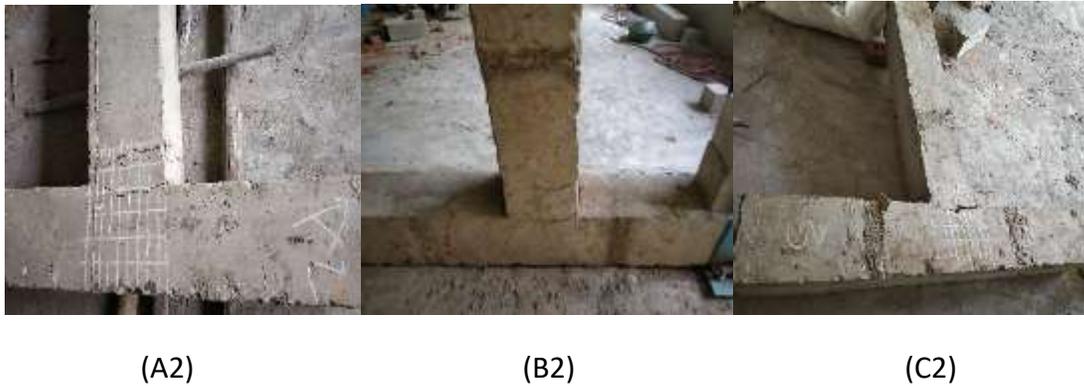
The anchorages and joint details of specimens A2, B2 and C2 are shown in Fig 10, respectively. It can be seen from Fig. 10 that shear cracks have developed in the beam-column junction and diagonal cracks have developed in the column shear panel area of all the specimens and the wide-open crack pattern can be observed only in the specimens B2 and A2. In addition, the concrete had spilled out from the specimens B2 and A2 with buckling of beam longitudinal reinforcement. In Group-II, specimen C2 (mechanical anchorage) has the lesser crack pattern with only a few diagonal cracks were formed at joint core than specimens B2 and A2.

**Figure 10: Crack pattern of Group-2 (A2, B2, & C2)**

In this performance study towards cracks of all these specimens, the specimen C1 shows an excellent performance with few shear cracks. Fig. 10. Crack Pattern of Group-II (A2, B2, C2) The specimens have  $90^{\circ}$  bent tensile anchorage bars which induce a compressive stress in the joint diagonally forming a compression strut due to contact pressure under the bend. Tension tie developed in the joint perpendicular to the direction of the strut induces a tensile stress. Diagonal cracks are developed perpendicular to the direction of the diagonal tension tie in the
